**STS-103 (B1099)  
FLIGHT READINESS REVIEW**

**November 19, 1999**

**SOLID ROCKET BOOSTER**

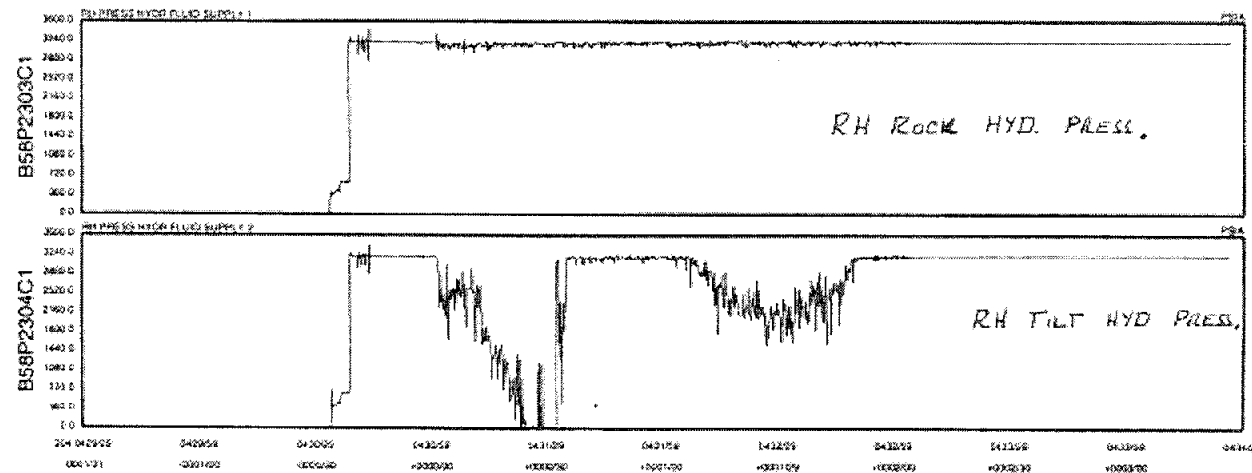
- RH TVC tilt hydraulic pressure measurement became erratic during ascent

- Pressure measurement provides data during T-17 seconds to T-10 seconds for launch commit
- Worst case impact is launch scrub (Criticality 3)

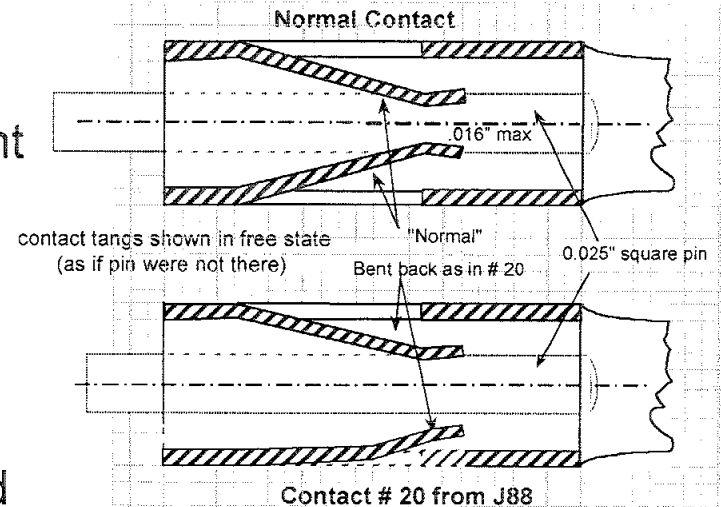
- Failure was not repeated
  - Pressure transducer vibrated at flight levels (sixteen additional missions)
  - Watertight reusable cable X13W3R visually inspected and electrically tested
  - Aft skirt throwaway cable X02W11 visually inspected, electrically tested and subjected to destructive failure analysis
  - Aft IEA S/N 61 visually inspected, recertification tested, and vibration tested
- MDM static testing complete (no anomalies)
- Amplifier Buffer Attenuator (ABA) card testing completed (no anomalies)
- Internal inspection of IEA found one ABA card edge connector contact damaged

- Intermittent open circuit on this contact would cause observed anomalous condition (failure mode validated with circuit analysis)
- Isolated case - 1,485 contacts inspected
- This type of contact only used in Criticality 3 circuits
- IFA to be closed as an unexplained anomaly; most probable cause is damaged ABA connector contact

- Improved connector/contact visual inspection for these IEA signal conditioner connectors
- Visual inspection to be performed prior to reinstalling replaceable units into these connectors each time

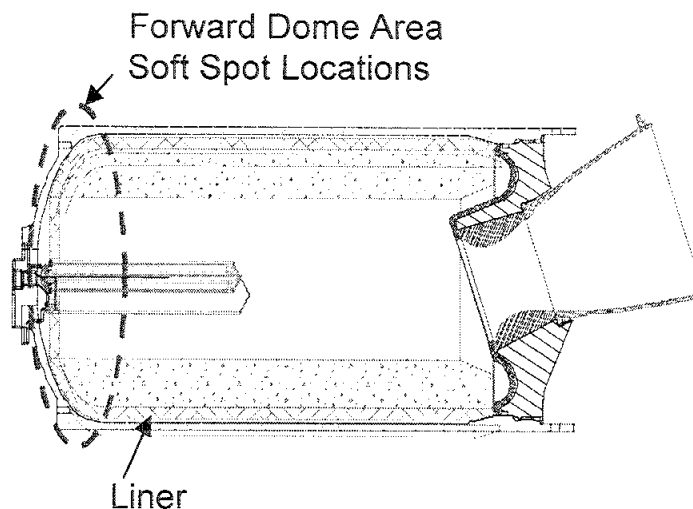
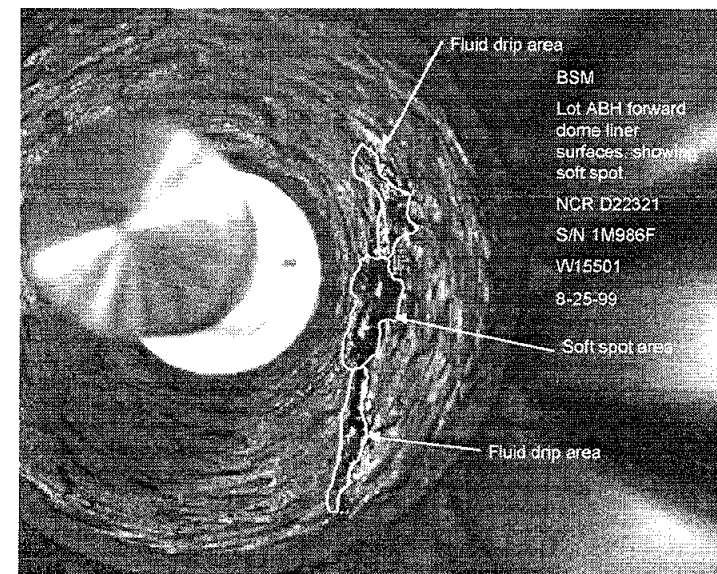
- Liner soft spots observed in the BSM forward dome and case wall liners during production of Lots ABG, ABH and ABJ

- Forward dome burn through and/or propellant debris

- Total of 180 BSMs in Lots ABG, ABH and ABJ
- Seven motors had one soft spot each
  - Lot ABG (1); Lot ABH (2); Lot ABJ (4)
  - One Lot ABH BSM propellant machined out of case and one soft spot identified in liner on case wall
- No history of anomaly prior to Lot ABG
- BSMs installed on STS-103 from different lots (ABC, ABD and ABE)

- Investigation and testing identified root cause of soft liner to be the liner mixer in Station 250
  - Mixer rotation not in correct direction
  - Wiper blade is installed upside down not properly wiping the bowl wall
  - Mixer was only used by CSD for liner Lots ABG, ABH and ABJ
  - Uncured liner material taken from mixer side wall shows Lots ABG, ABH and ABJ produced material below specification
- BSM production Lots ABF and earlier were produced with Station 20 mixer

- Detailed review and update of liner process floor paper conducted
- Lots ABG, ABH and ABJ have been placed in bonded storage

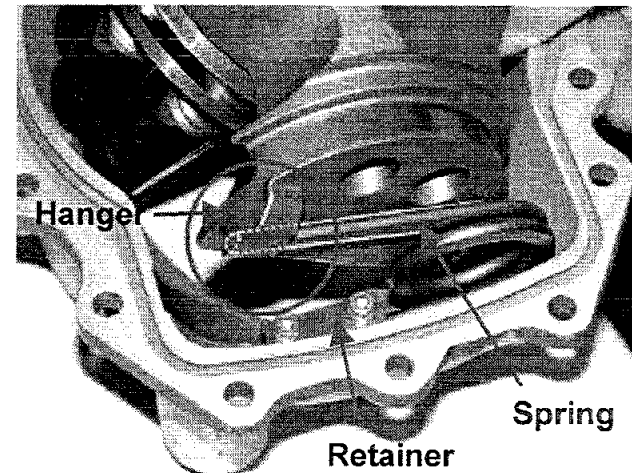
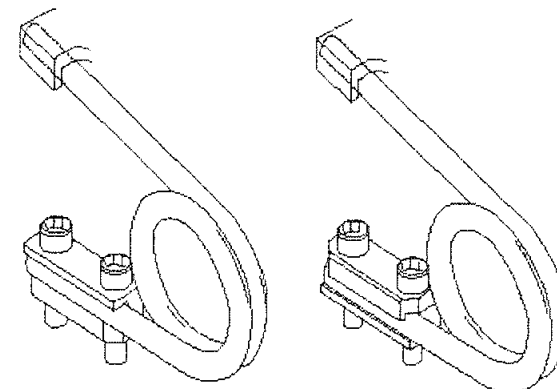
Retainer Configurations

- Orbiter found Hydraulic Pump torsion spring not properly seated in hanger

- Could cause erratic discharge pressure or loss of hydraulic system function

- Radiographic Inspection (RT) found to be excellent method to determine if springs are in hangers
- SRB found one pump in stores with both springs out of hangers
- Analysis shows 1900+ g's required to lift spring out of hanger
- RT of STS-103 orbiter and SRB hydraulic pumps performed (springs installed in hangers)
- Retainers used to secure torsion spring to pump housing not installed per drawing
  - Vendor testing verifies pump performance nominal with retainer installed in either configuration

- Verification techniques of proper installation after vendor refurbishment under evaluation
- Vendor engineering change in work to allow observed retainer configuration as alternate
